West Slope Watershed

Description of the watershed

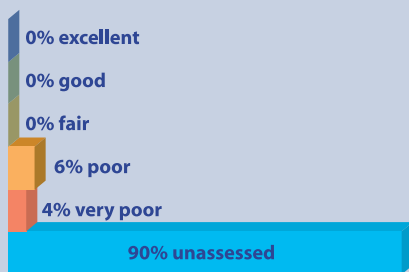
The following bar charts show overall watershed health ratings from four perspectives. Approximately 90 percent of the watershed is not assessed using actual field testing. However, the watershed's land uses — fairly extensive rural and suburban residential areas — the lack of forests, and presence of I-5 suggest that streams will be in poor health.

Overall health

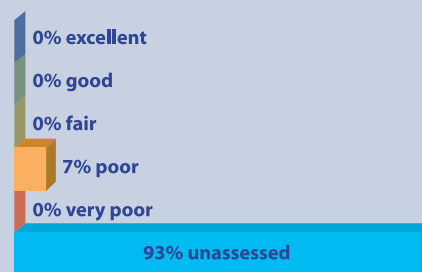
Stream life health based on health of streambed creatures

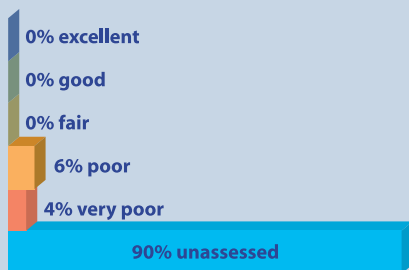
Health for recreational use based on presence of harmful bacteria

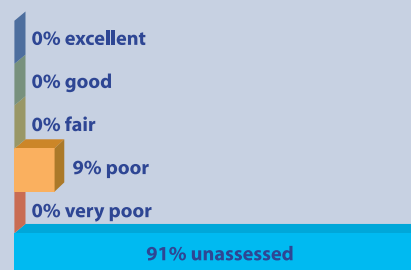
General water quality based on temperature, pH, dissolved oxygen
